Bangalore's Toxic Legacy Intensifies

Status of Landfills, Waste Processing Sites and Dumping grounds, and working conditions of Pourakarmikas

A special focus on continuing toxic impacts of landfills in Mavallipura

February 2018

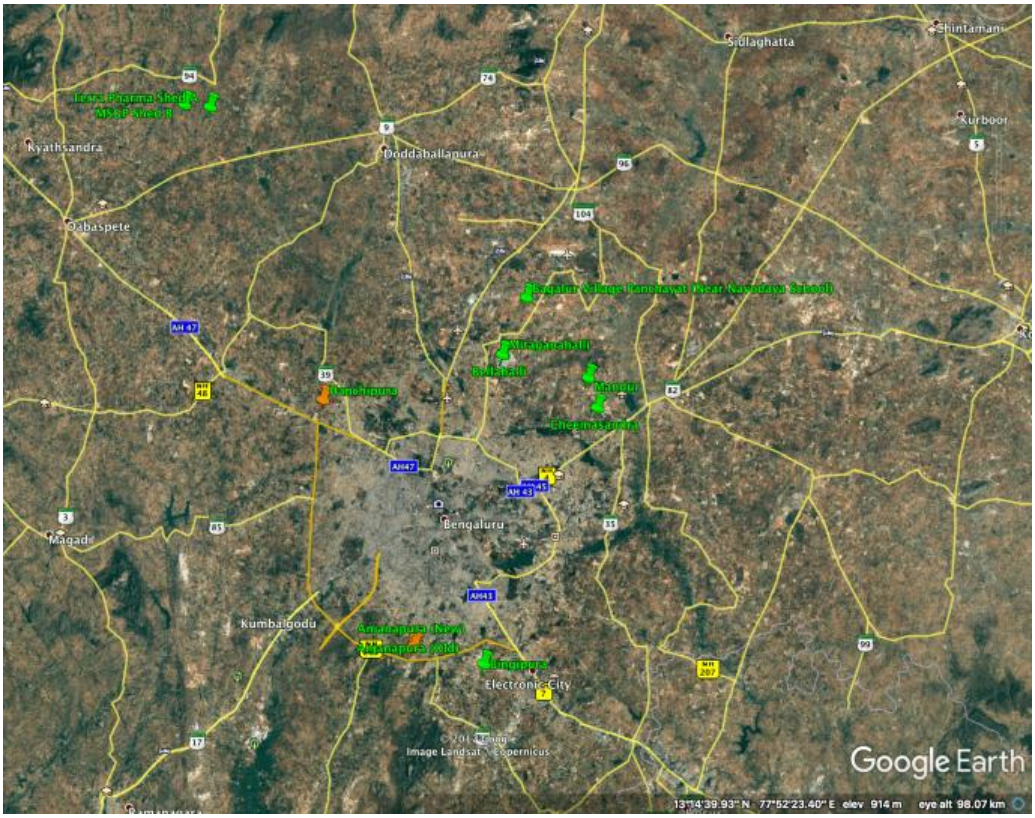
Figure 1 Google Overview of approved and unapproved landfill sites in Bengaluru

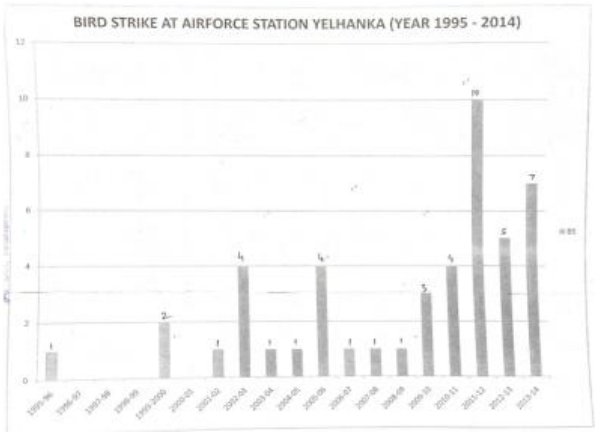
"Like various operational air bases of IAF, various measures are undertaken at Yelahanka Air Base to combat Bird Hazard. These preventive measures are also undertaken in areas outside the air base upto 20 kms. radius from the airbase. One such case in point was action by the IAF to demolish a fish pond at Razak Palya village." [A note enclosed revealed that between 1995-2014, there were anywhere between 1 bird strike (1995-96) and 10 bird strikes (2011-12) annually. It is only between

Figure 21 Bird Strike at Airforce Station Yelahanka (Year 1995-2014)

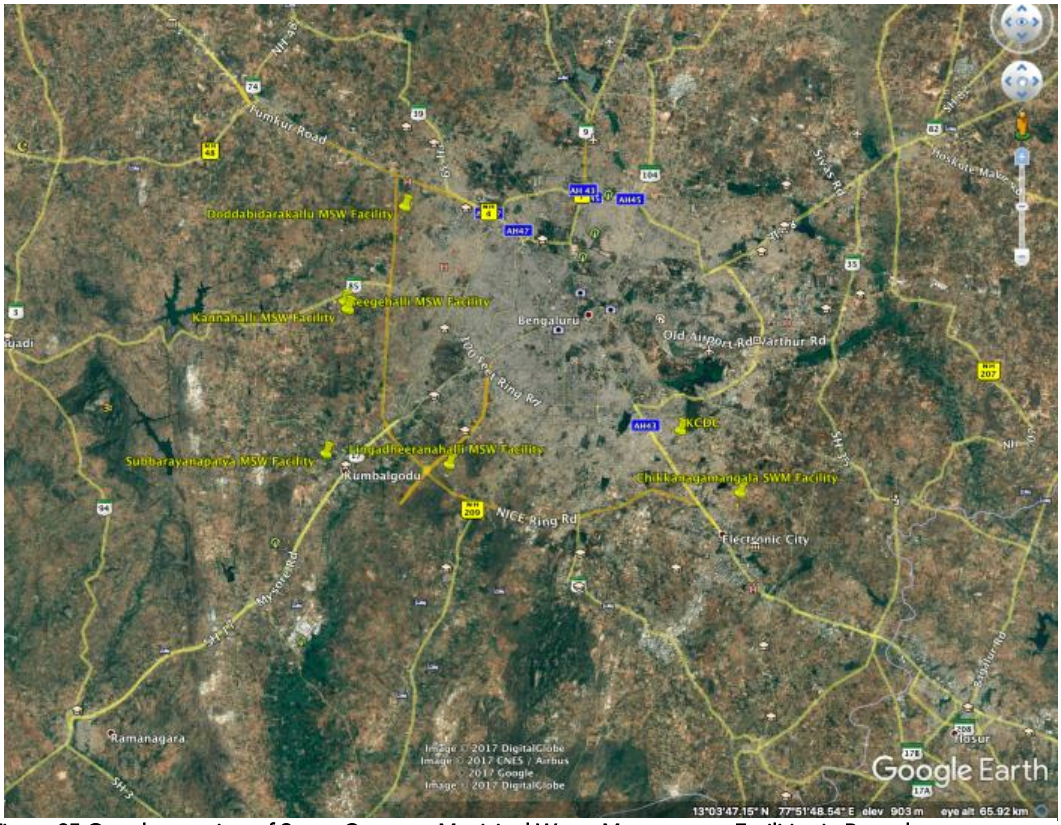
Figure 25 Google overview of Seven Common Municipal Waste Management Facilities in Bengaluru

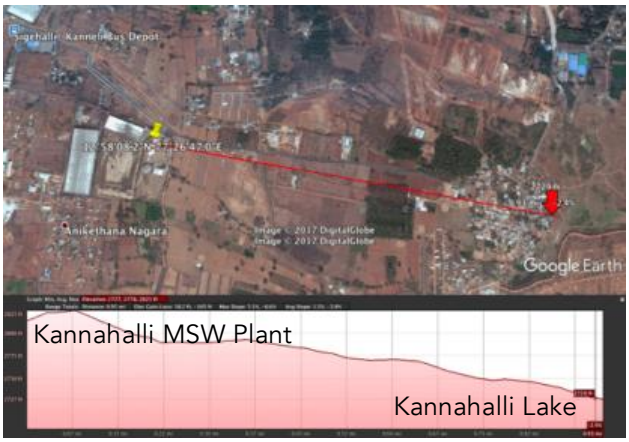
Figure 26 Google Earth overview of the Kannahalli MSW Treatment Plant (Including elevation details from MSW Plant to Kannahalli lake downwards)

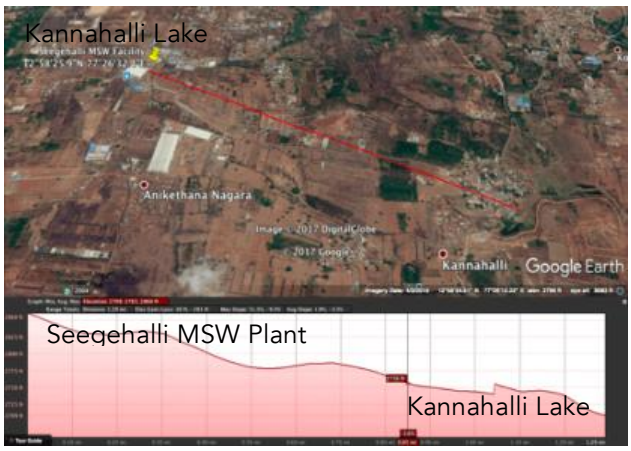
Figure 32 Google Earth overview of the Seegehalli MSW Treatment Plant (Including elevation details from MSW Plant to Kannahalli lake downwards)

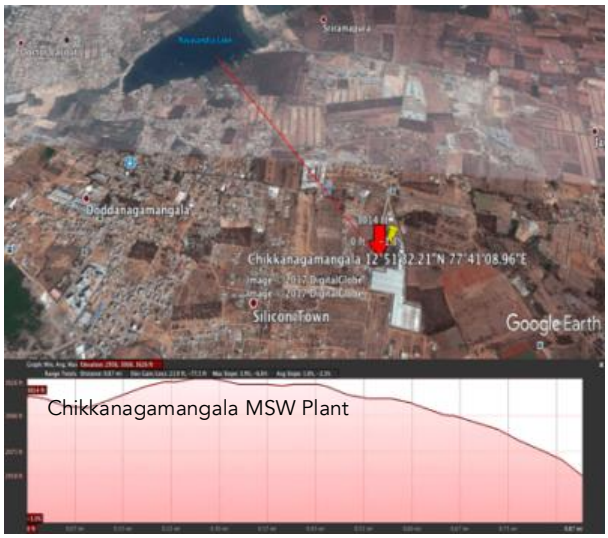
Figure 50 Google Earth overview of the Chikkanagamangala MSW Treatment Plant (Including elevation details from MSW Plant to Rayasandra lake)

- This facility is not operational now. It is awaiting review of BBMP's to consider its re-operation.
- Project Proponent: Bruhat Bengaluru Mahanagara Palike
- Nodal Agency: Karnataka Urban Infrastructure Development and Finance Corporation,
- Total Site Area: 25 acres;
- Storage Capacity: 6000 tonnes,
- Processing Capacity: 500 TPD mixed waste.
- Leachate tank capacity: 35000 L
- Trucks: 40 trucks i.e. 500 TPD (once it is start working)
- Workers: 120 workers (when operational)
- No Sanitary landfill available at the site.
- No leachate treatment plant installed.
- No odour control facility

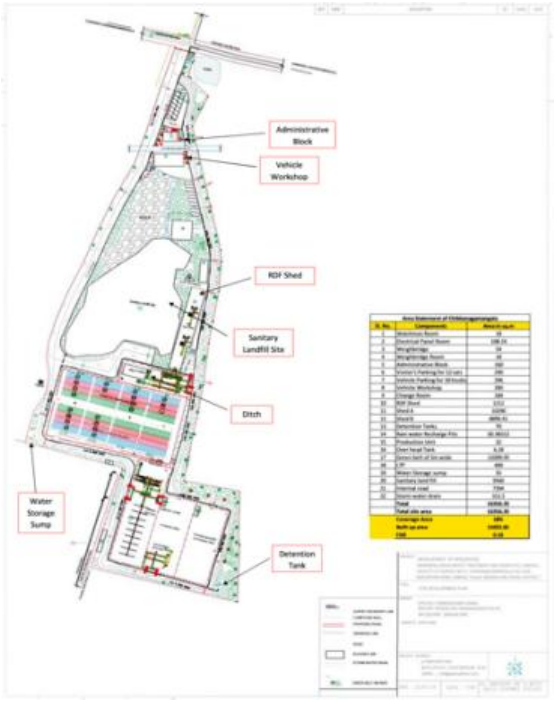
Figure 51 Chikkanagamangala MSW Facility layout plan

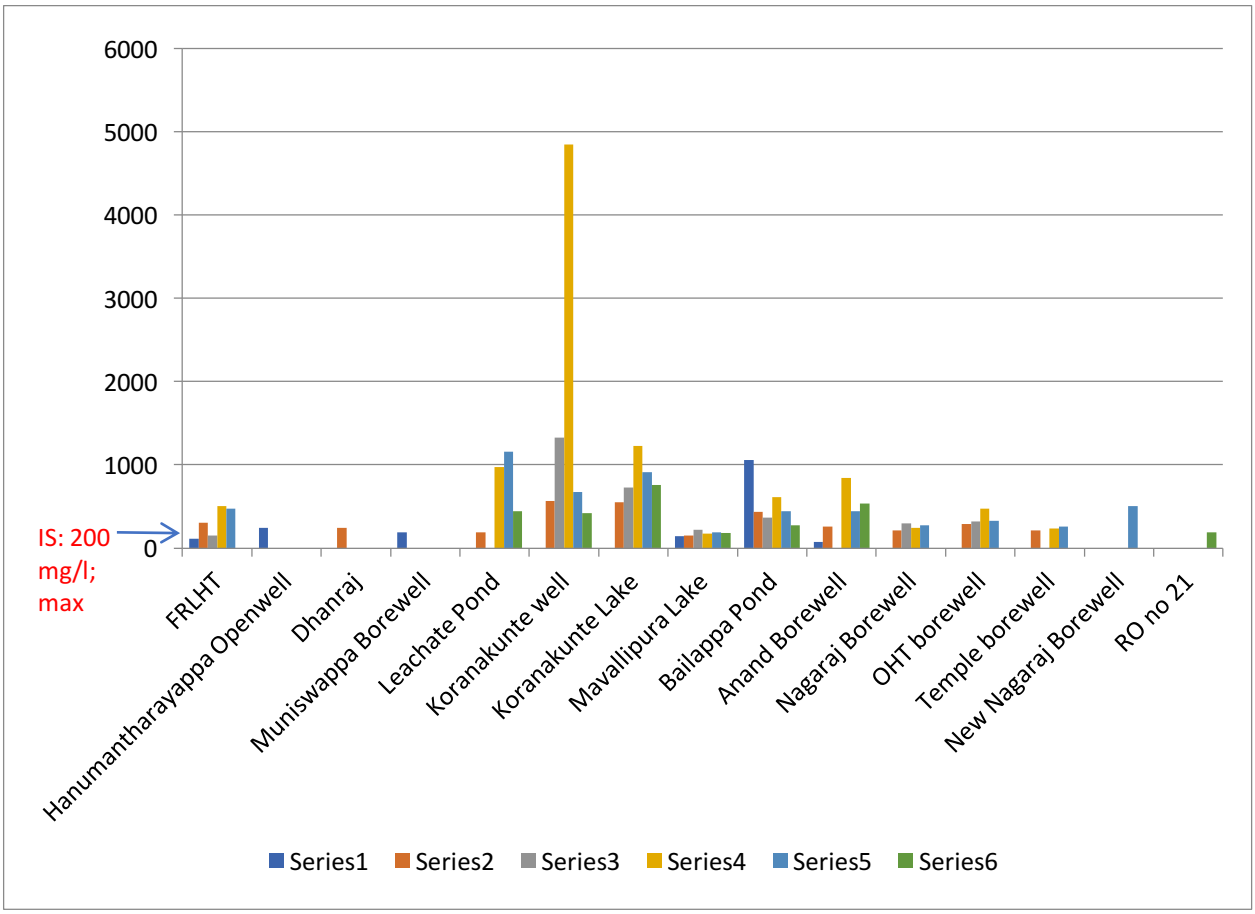
Analysis: The desirable limit as per IS 10500/2012 is 200 mg/L, Max.

With the exception of Mavallipura lake site and the Reverse Osmosis Drinking Water plant at Mavallipura village, other samples displayhardness beyond desirable limits (200mg/L) in 2016 data. The Ramky leachate pond site displayed hardness beyond permissible limits at all-time points except 2009 (2006: 1060 mg/L, 2012: 720, mg/L 2016: 1160 mg/L). Both the Koranakunte Lake and open well displayed hardness beyond permissible limits in 2012 and 2016, ranging from 670 mg/L to 1012 mg/L.

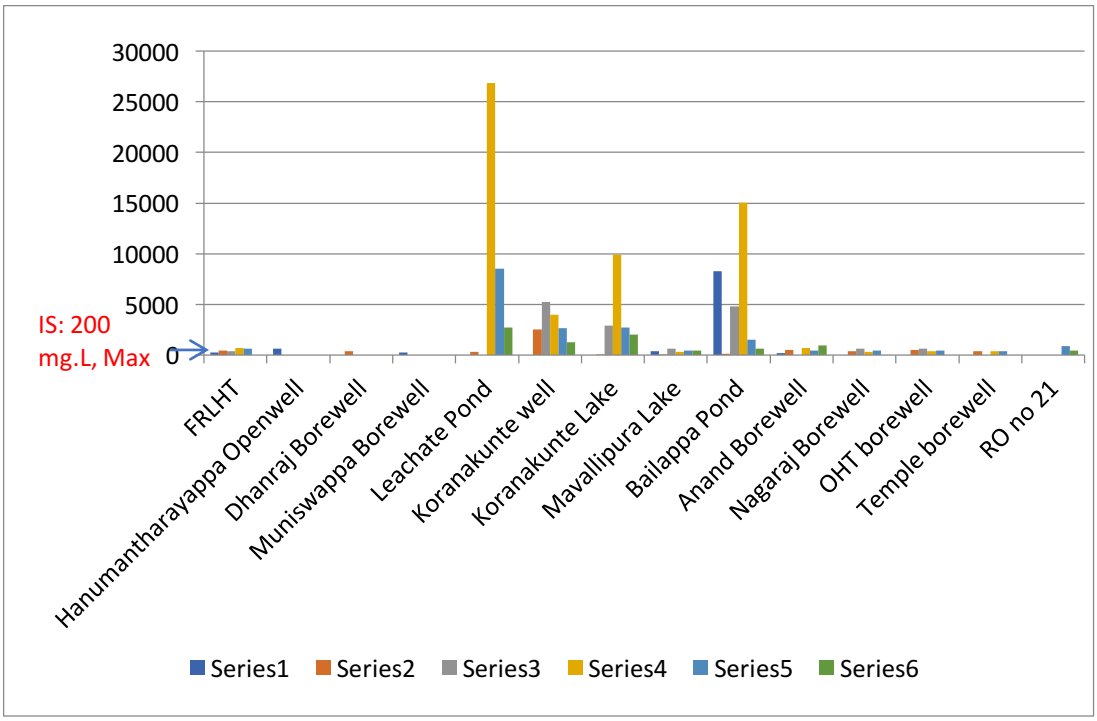
Analysis: The desirable Limit as per IS 10500/2012 is 500 mg/L (max). TDS remains beyond permissible limits (2000 mg/L) at sampling sites which are within a mile of the landfill, indicating, therefore, that the leachates from the landfills are impacting the quality of water. In Koranakunte well and the Koranakunte lake, TDS was beyond permissible limits at all recorded time points with highest measurement of 9940 mg/L (five times the permissible limit) in 2012. At the Ramky leachate pond, with the exception of the sample taken in 2009, TDS ranged from 4 to 13 times the permissible limit (2006: 8275 mg/L, 2012: 26850 mg/L, 2012: 8500 mg/L).

Impact: Water with high TDS is unacceptable for consumption and imparts an undesirable taste. It may also cause gastrointestinal infections.

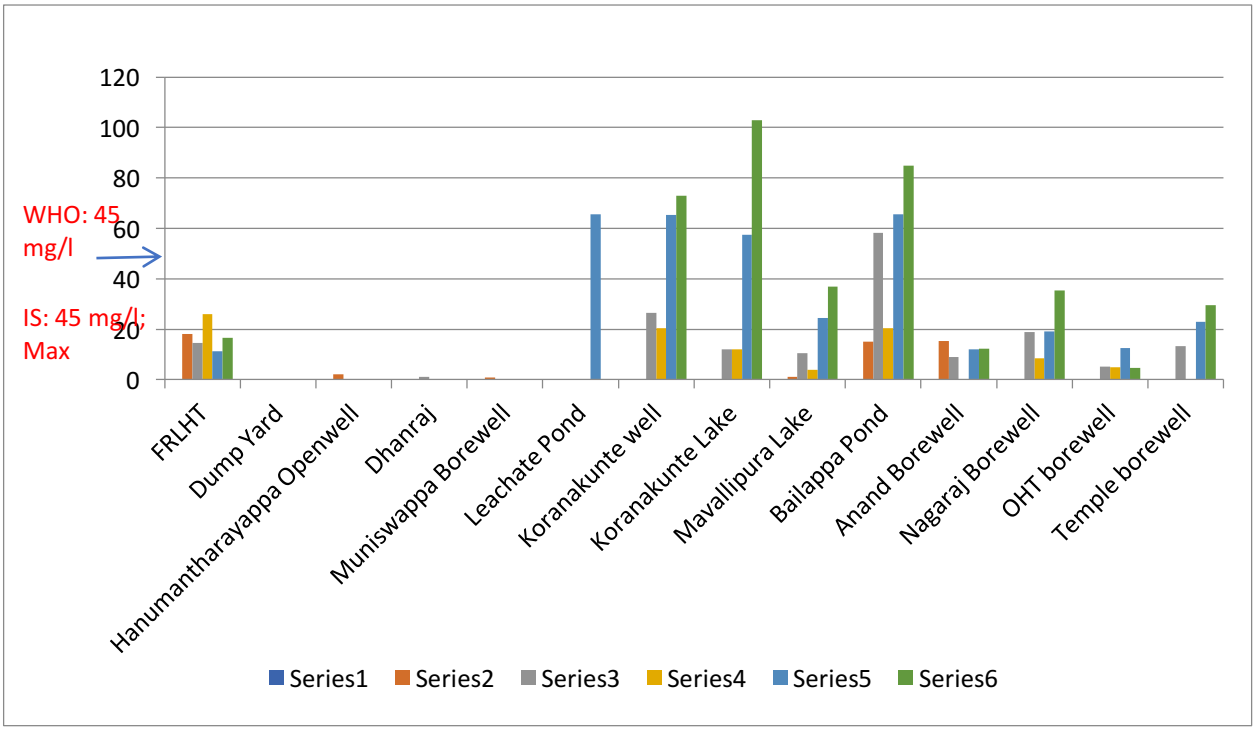
Increase in level of nitrates at sites closer to landfill is worrisome. Of special concern is that some sites that had recorded safe level of nitrates in the past have crossed the desirable and permissible threshold of 45 mg/L over time. Like in Koranakunte well (2009: 26.6 mg/L, 2012: 24.2 mg/L, 2016: 72.9 mg/L), and in Koranakunte lake (2009: 11.93 mg/L, 2012: 57.42 mg/L, 2016: 102.8 mg/L). At sites that are over a mile away from the landfill, though they are within acceptable limits, there is a concerning upward trend that can be observed. (For example: at the temple bore well 2009: 13.4 mg/L, 2012: 18.5 mg/L, 2016: 29.62 mg/L). Mavallipura tank and Nagaraj well with recorded values above 35mg/L in 2016 show trends similar to temple bore well.

Impact: The presence of high nitrate at different sampling sites indicates the possibility of high contamination from organic matter. The most susceptible population which can be impacted due to high levels of nitrate are infants. High nitrates present the high risk that they may convert into nitrites, which increases the risk of methemoglobinemia in bottle-fed infants, a condition in which haemoglobin can carry oxygen, but is not able to release it effectively for building body tissues.

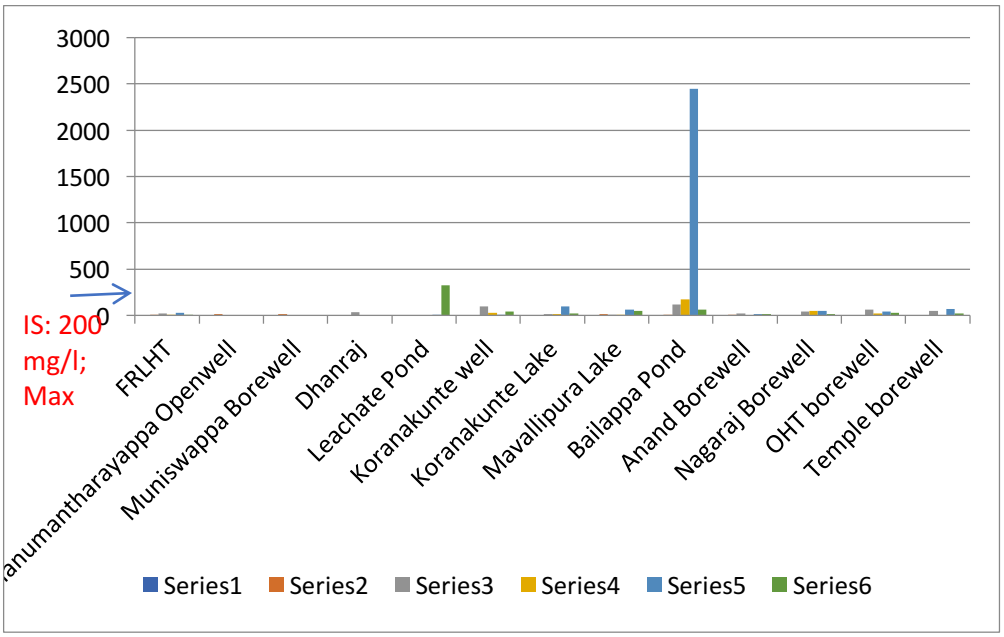
Analysis: The desirable & permissible limit (max) for 200 & 400 mg/l. Water sample from Bailappa pond drawn in 2012 showed sulphate at a whopping level of 2450 mg/l. In 2016, the sulphate level at Ramky leachate pond was at 326 mg/l.

Impact: High levels of sulphate in water can affect the taste of the water, it lends a bitter, medicinal taste to water. The consumption of such water can result in a laxative effect leading to diarrhea and dehydration.
